Technical Memorandum

To:	Mr. Dale Reed	From:	Mark Abshire, P.E.
Company:	Merrimac Fort Partners, LLC	Date:	June 10, 2022
EA No.:	111217		
Re:	Lots 161C-R, 67, 69R-2, and 71R Mountain Village, Colorado Geotechnical Engineering Investigation Status Update		
Cc:	Mr. Bill Thompson (Fort Partners)

**GEOTECHNICAL ENGINEERING INVESTIGATION
FOR SHORING AND FOUNDATIONS**

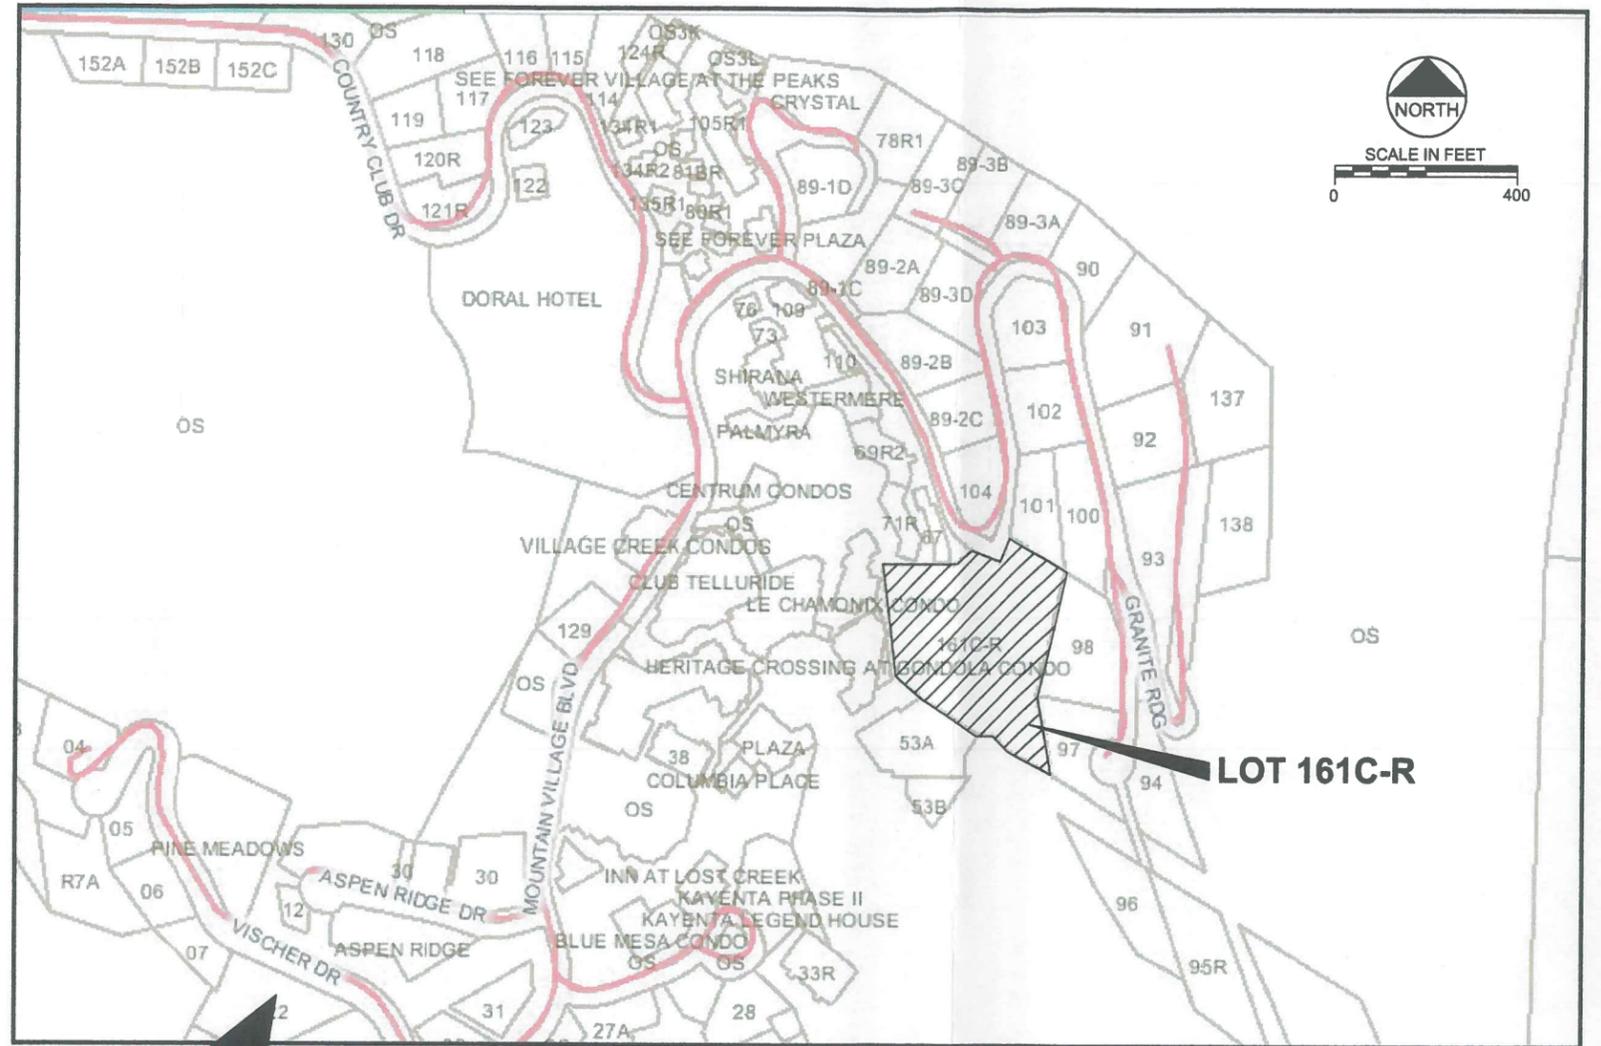
**FIGURE 3-1
LOT 161C-R MOUNTAIN VILLAGE, CO
SITE VICINITY MAP**

MOUNTAIN VILLAGE CORE VICINITY MAP

Lot 161C-R is located in the NW¼, NE¼, Township 42N, Range 9W (New Mexico Principal Meridian), San Miguel County, at One Gondola Place in the Town of Mountain Village, Colorado (Figure 3-1). Access to the lot is from the north via Mountain Village Boulevard. The building envelope extends to within several feet of the irregular lot boundaries on nearly every side. The lot is bordered on the west by the La Chamonix and Heritage Crossing hotel/condominium/retail developments, and on the south by the Mountain Village/Telluride Gondola base. Residential structures occupy Lot 97 above the southeast corner of the lot and Lot 101 above the northeast corner of the lot. Other adjacent lots on the east and north are undeveloped. Utilities run along the unpaved temporary service road which passes through the site from north to south.

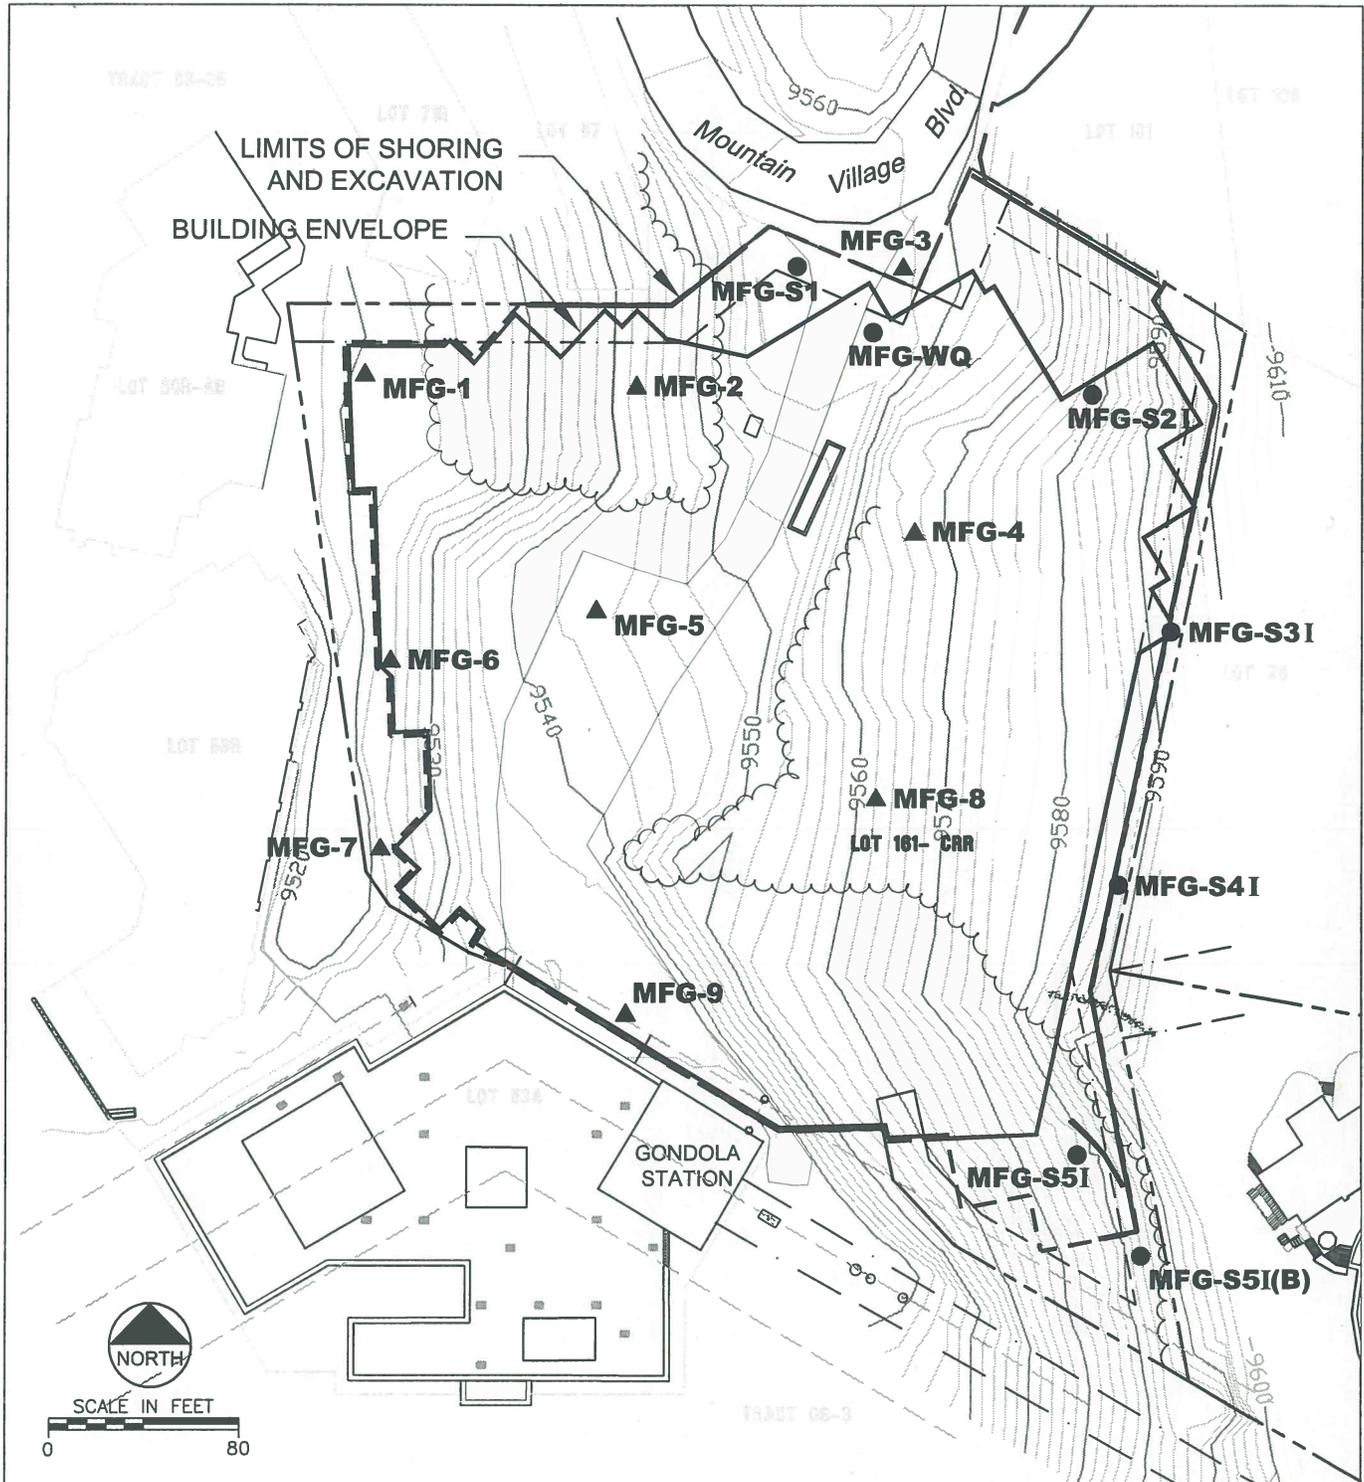
LOT 161C-R MOUNTAIN VILLAGE, CO		
FIGURE 5-1		
BORING LOCATION MAP		
PROJECT: 181308	DATE: NOVEMBER 2006	
REV:	BY: TGB	CHECKED: MSA
MFG, Inc. <i>consulting scientists and engineers</i>

- SHORING INVESTIGATION BORING LOCATION
- ▲ FOUNDATION BORING LOCATION

Subsurface conditions at the site were investigated by drilling a total of 16 borings within or immediately outside the building envelope at the approximate locations shown on Figure 5-1. The borings were located to provide characterization of subsurface conditions across the building envelope; particular emphasis was placed on the west side to evaluate the influence of wetlands along that side, and on the east side to characterize subsurface conditions along the alignment of the tallest shoring. Ground surface elevations at the boring locations were estimated from topographic mapping provided by Foley Associates, Inc. (Final DRB Existing Conditions. October 3, 2006).

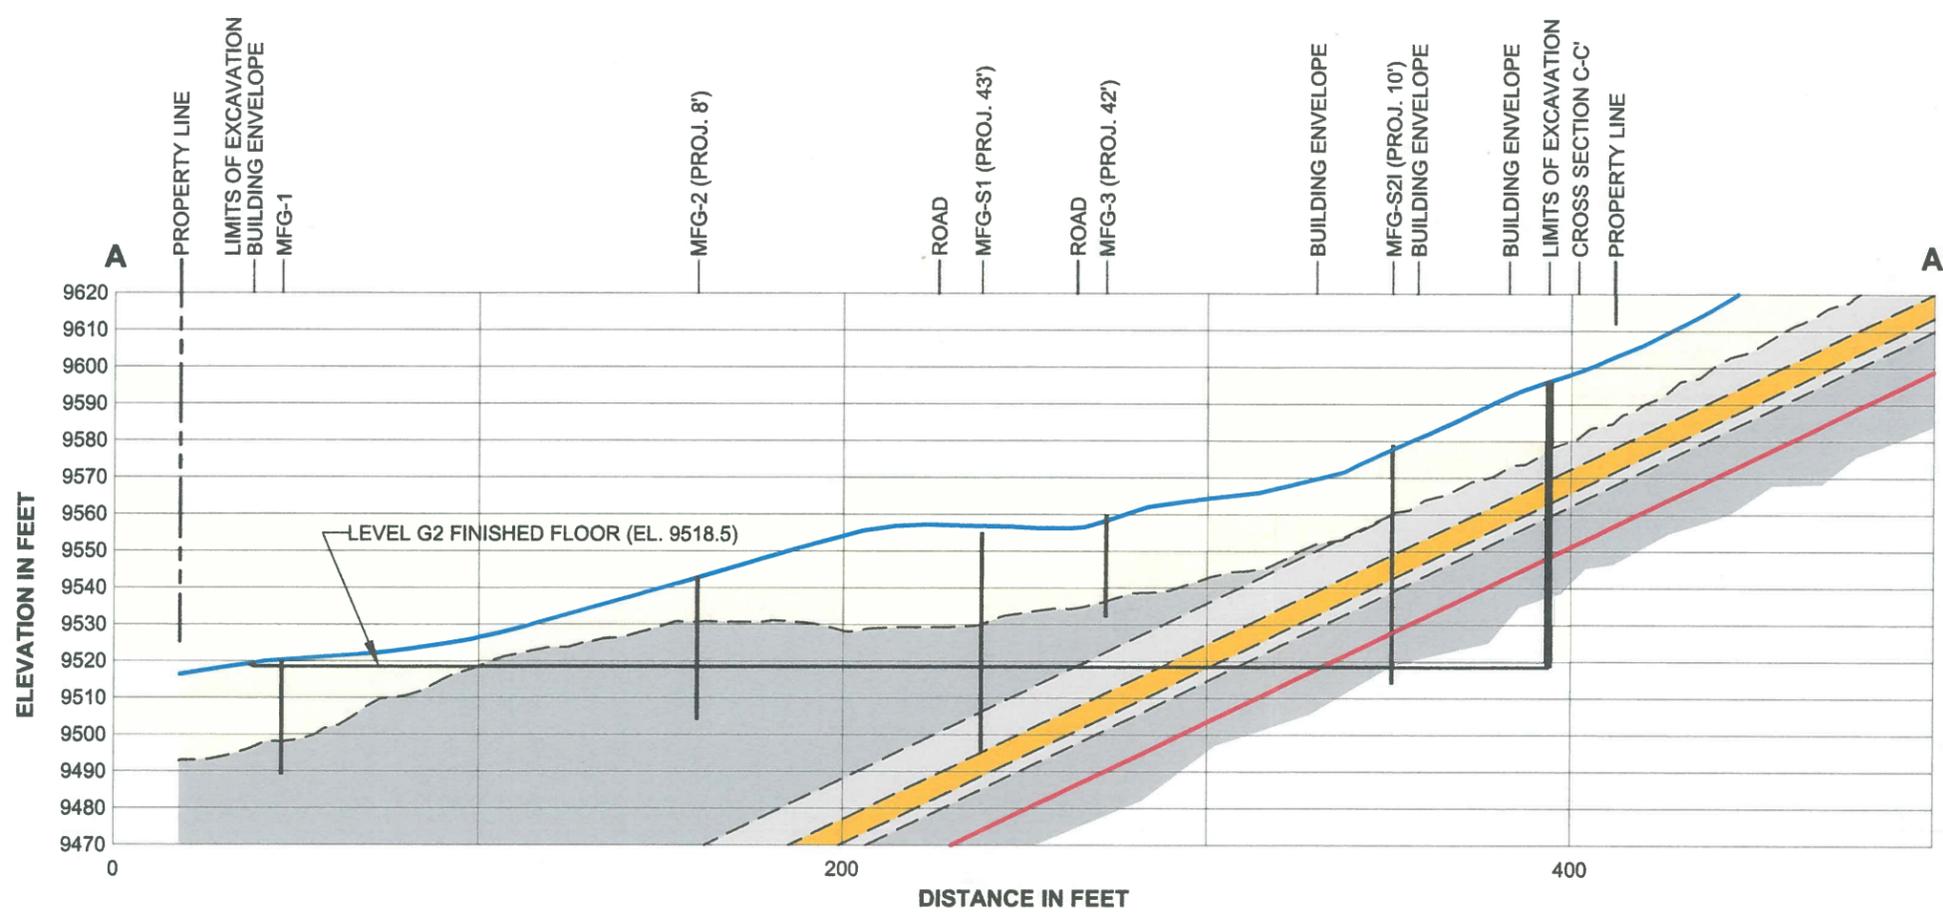
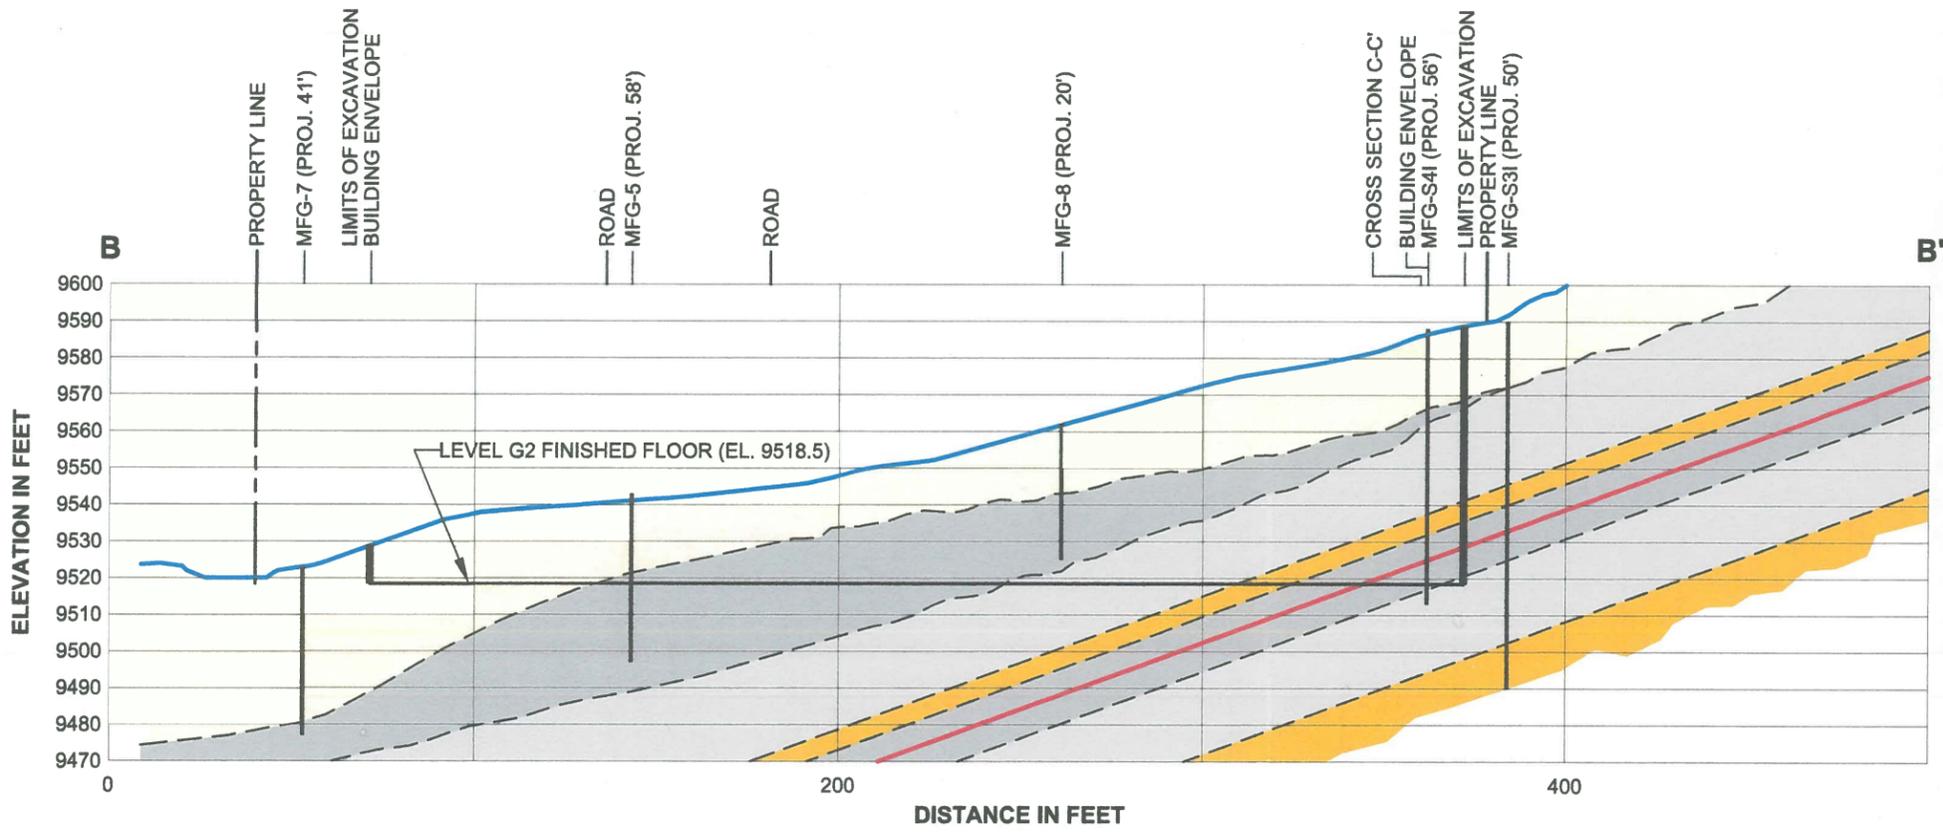
LOT 161C-R	
MOUNTAIN VILLAGE, CO	
FIGURE 9-2	
CROSS SECTIONS A-A' AND B-B'	
PROJECT: 181308	DATE: NOVEMBER 2006
REV:	BY: TC CHECKED: MSA
MFG, Inc. consulting scientists and engineers

- LANDSLIDE DEPOSIT
- SHALE
- INTERBEDDED SANDSTONE AND SHALE
- SANDSTONE
- COAL BED
- GEOLOGIC CONTACTS (DASHED WHERE APPROXIMATE)

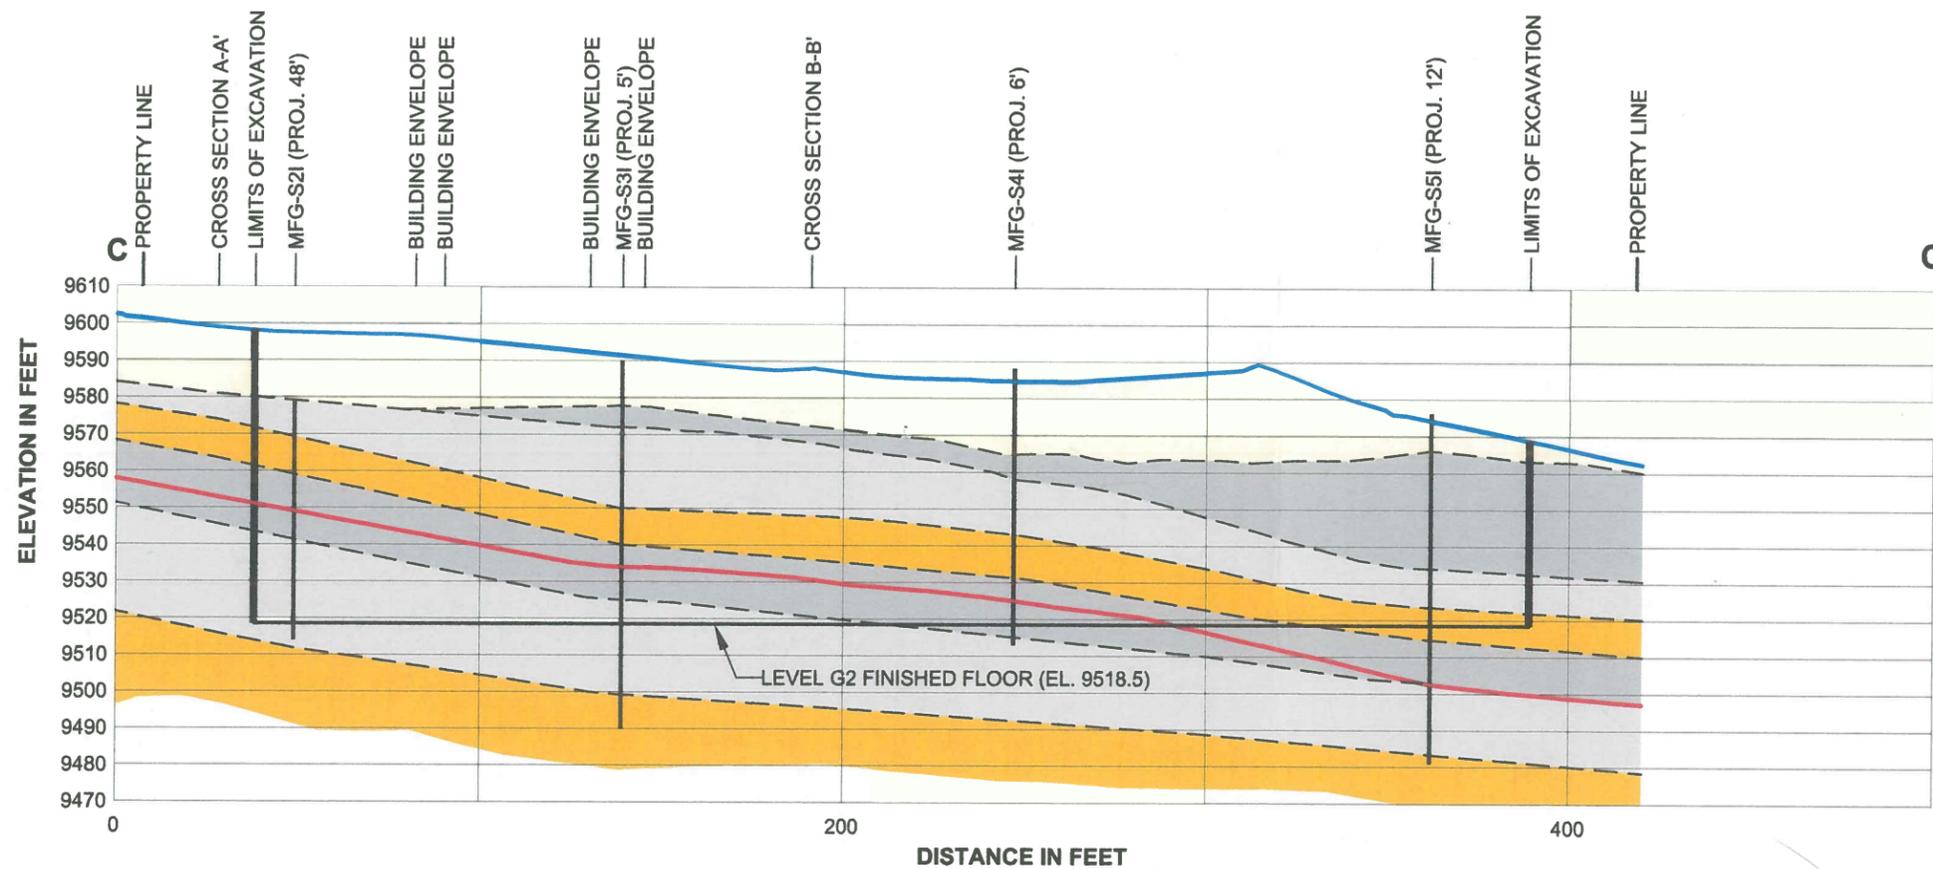
LOT 161C-R		
MOUNTAIN VILLAGE, CO		
FIGURE 9-3		
CROSS SECTION C-C'		
PROJECT: 181308	DATE: NOVEMBER 2006	
REV:	BY: TC	CHECKED: MSA
MFG, Inc.		
<i>consulting scientists and engineers</i>

- OVERBURDEN
- SHALE
- INTERBEDDED SANDSTONE AND SHALE
- SANDSTONE
- COAL BED

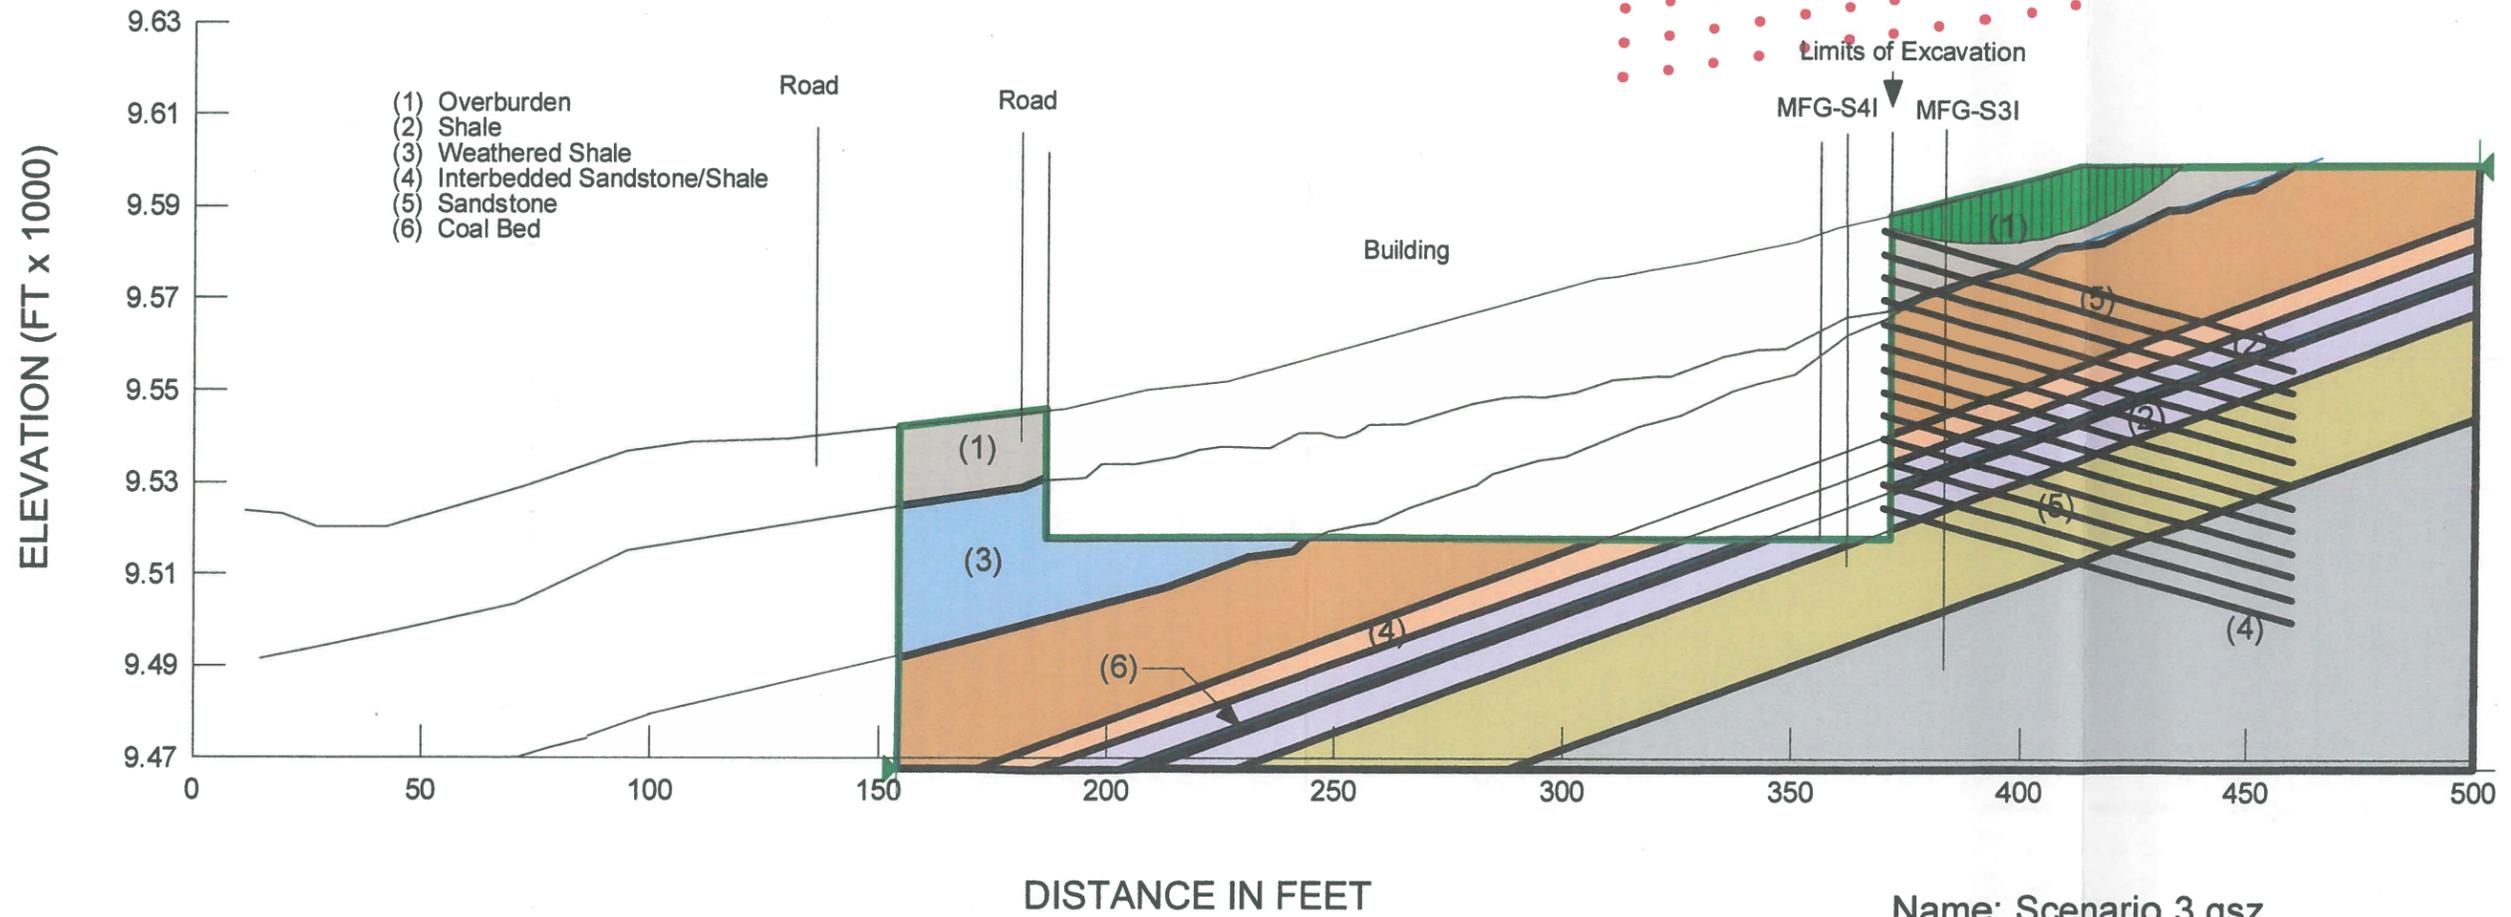
FIGURE 9-4
 CROSS SECTION B-B'
 SLOPE STABILITY SCENARIO 3

Slope Stability Analyses
 Cross Section B-B'
 Lot 191C-R
 Pseudostatic Case (0.17g)

- (1) Overburden
- (2) Shale
- (3) Weathered Shale
- (4) Interbedded Sandstone/Shale
- (5) Sandstone
- (6) Coal Bed

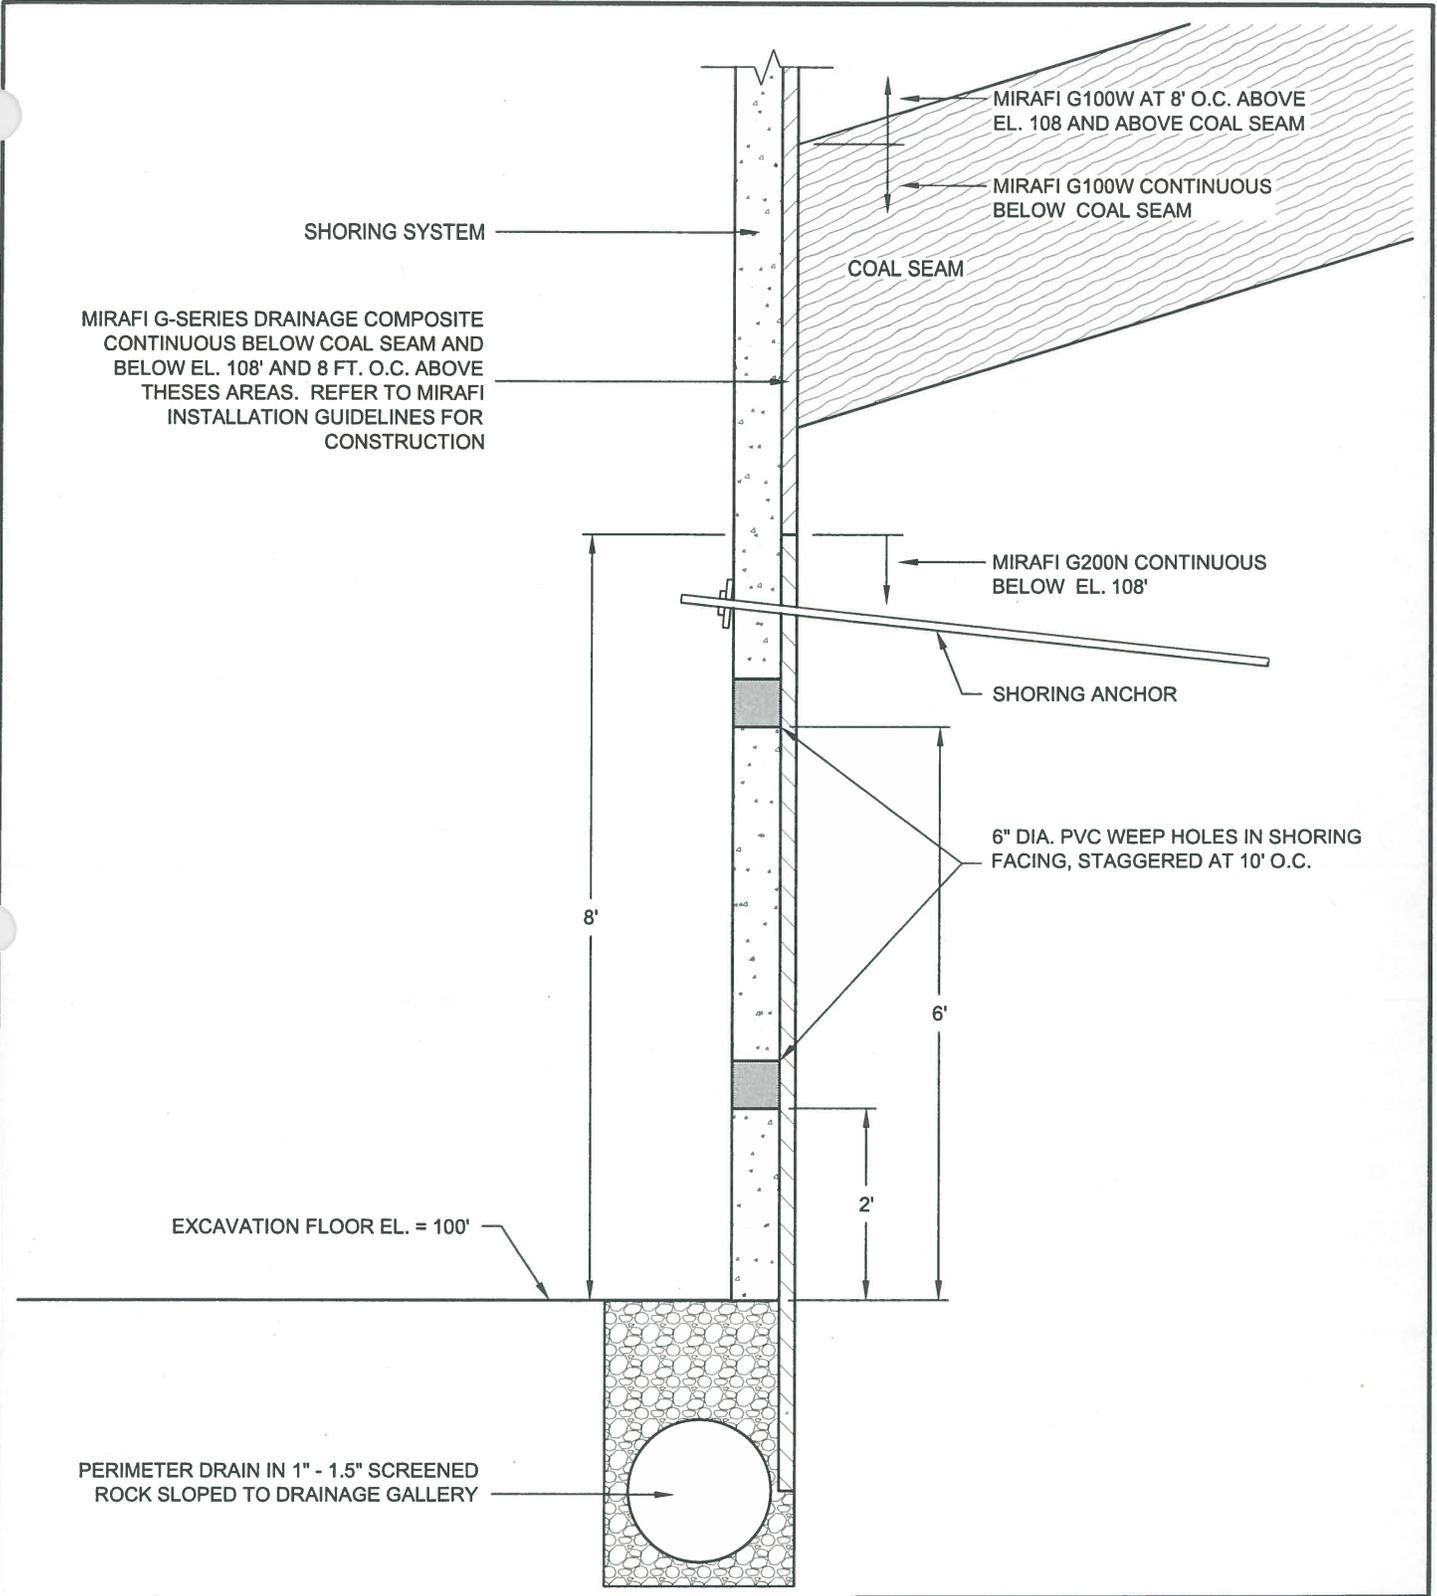
LOT 161C-R MOUNTAIN VILLAGE, CO FIGURE 11-2	
CONCEPTUAL SHORING DRAINAGE DETAIL	
PROJECT: 181308	DATE: NOVEMBER 2006
REV:	BY: TGB CHECKED: MSA
MFG, Inc. <i>consulting scientists and engineers</i>

MIRAFI G-SERIES DRAINAGE COMPOSITE CONTINUOUS BELOW COAL SEAM AND BELOW EL. 108' AND 8 FT. O.C. ABOVE THESE AREAS. REFER TO MIRAFI INSTALLATION GUIDELINES FOR CONSTRUCTION

EXCAVATION FLOOR EL. = 100'

freezing temperatures to minimize restriction or blockage of the system from ice buildup. A conceptual permanent shoring drainage detail is presented in Figure 11-2. The permanent shoring drainage system should be designed by a registered professional engineer.

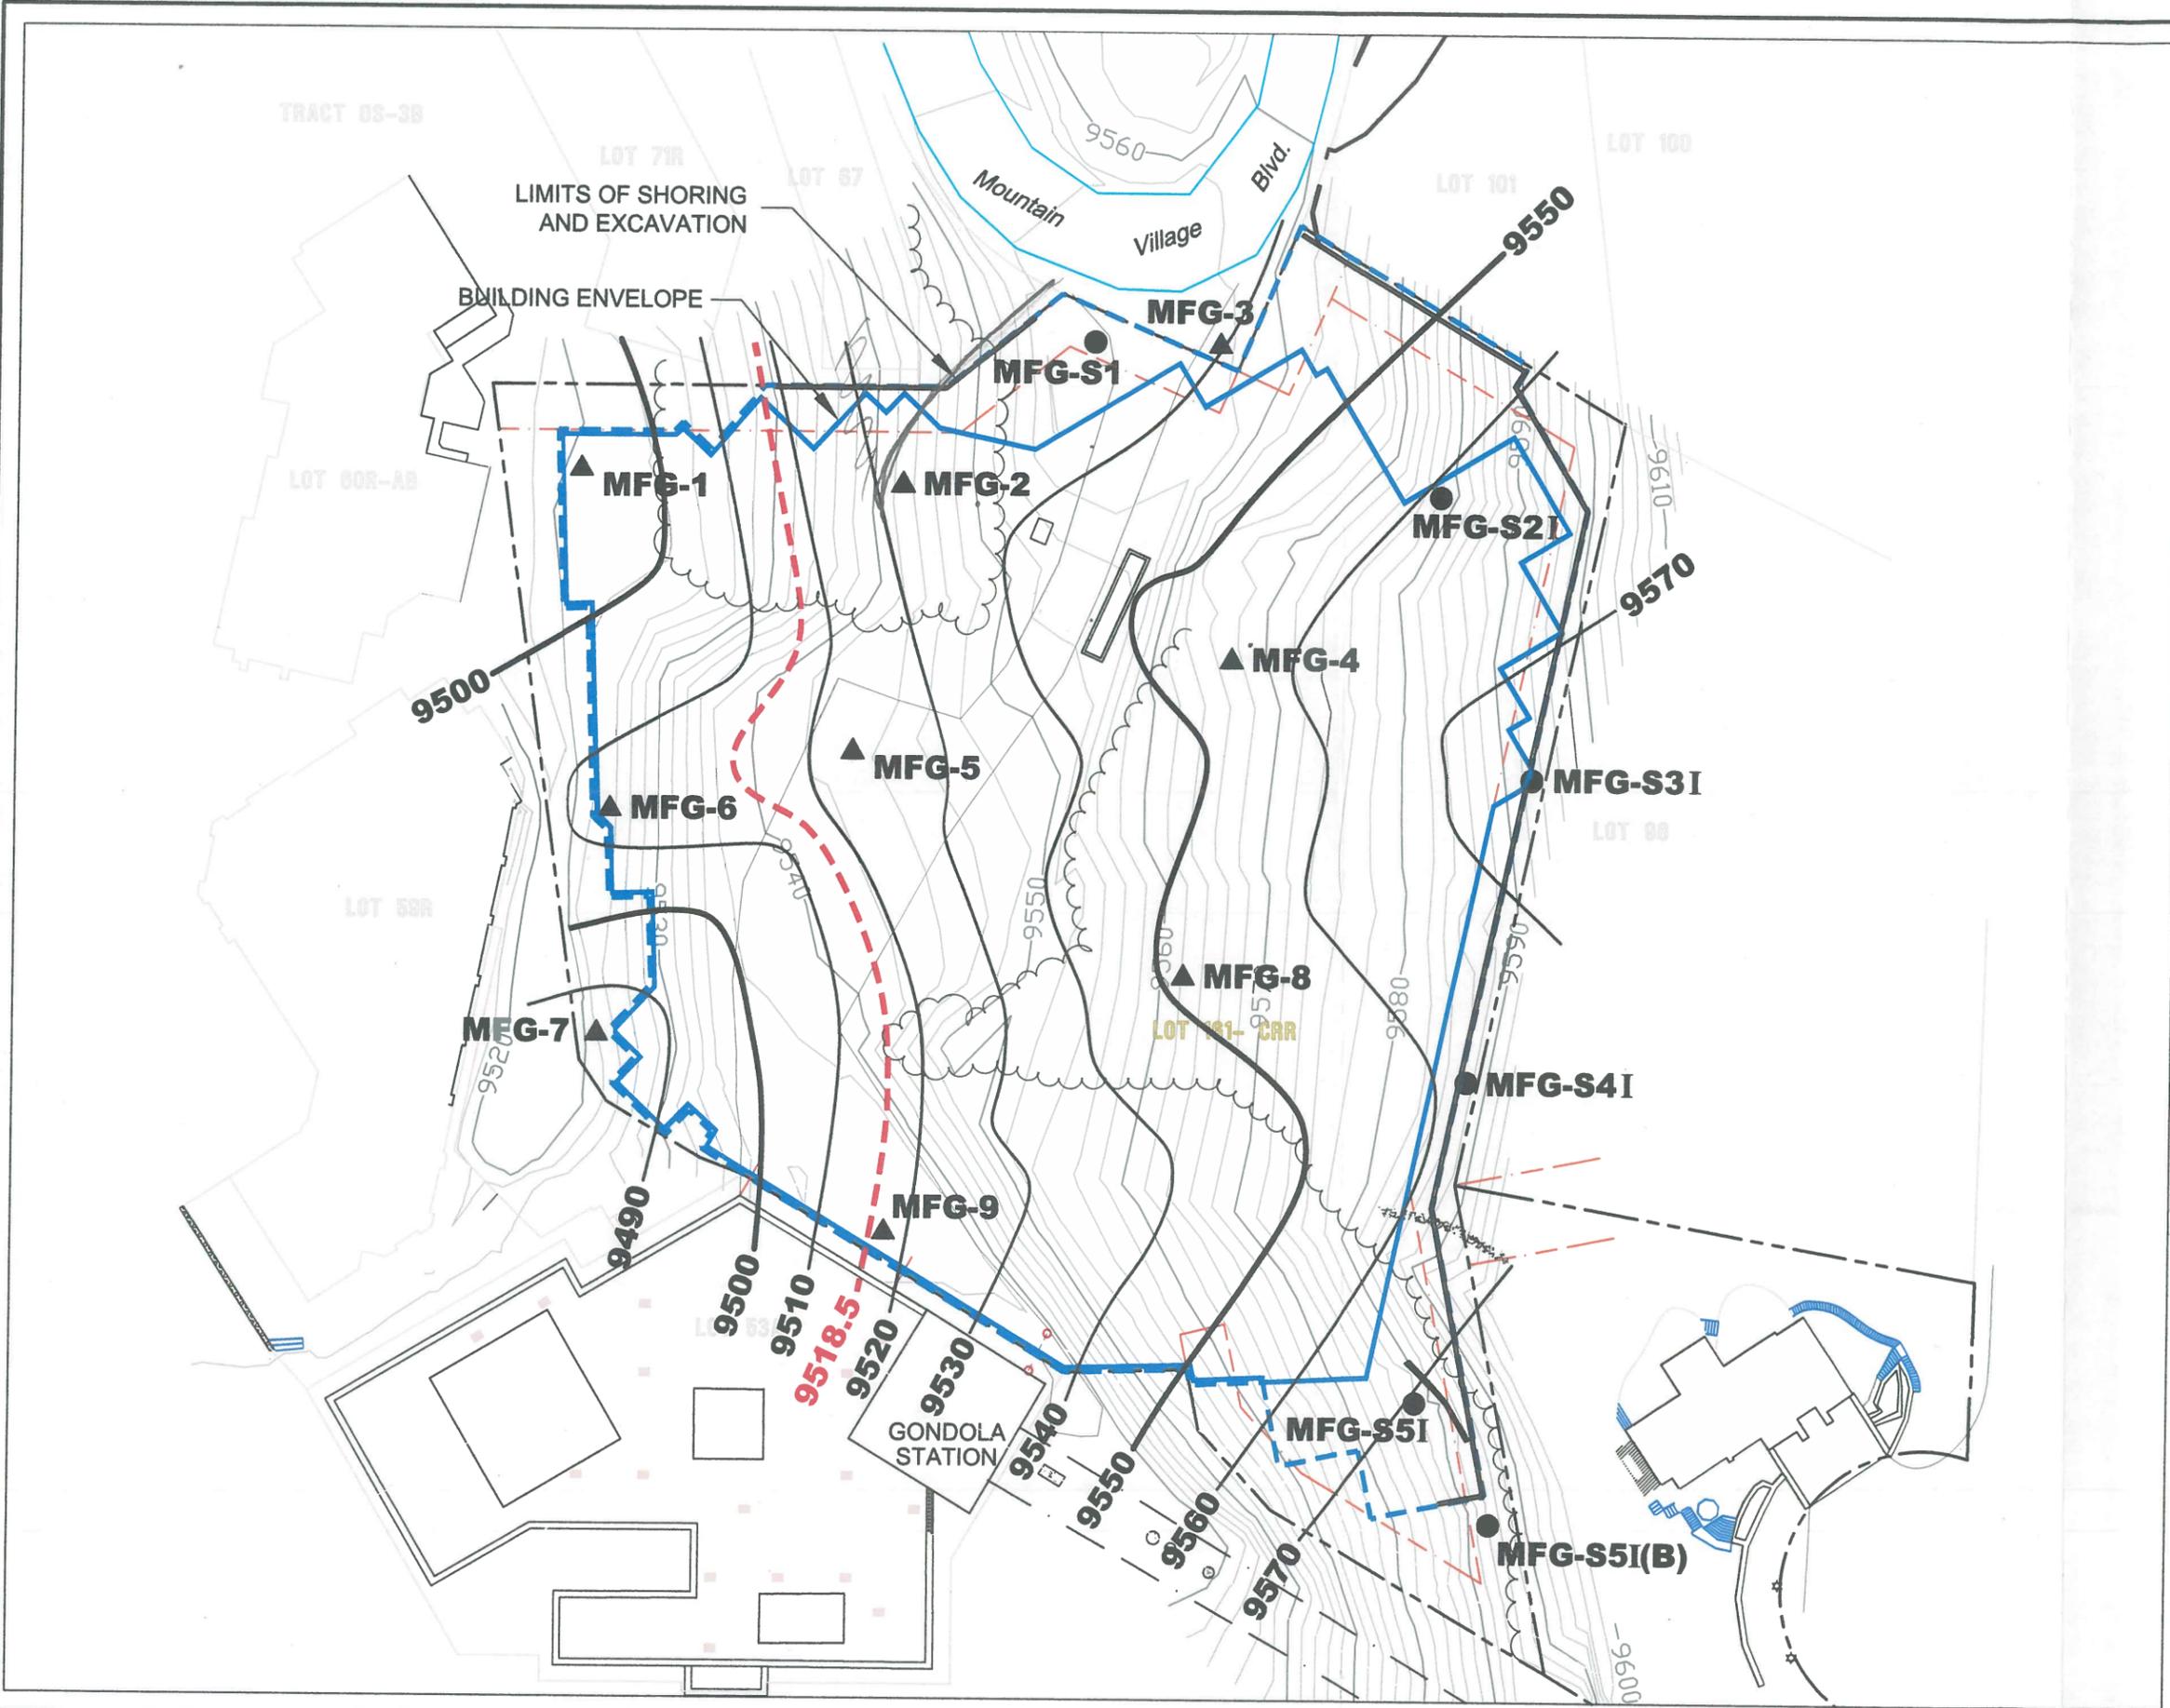
LOT 161C-R MOUNTAIN VILLAGE, CO FIGURE 12-1	
ESTIMATED BEDROCK SURFACE ELEVATION CONTOURS	
PROJECT: 181308	DATE: JANUARY 2007
REV:	BY: TGB CHECKED: MSA
MFG, Inc. <i>consulting scientists and engineers</i>

- LEGEND**
- ESTIMATED BEDROCK SURFACE ELEVATION CONTOURS
 - - - APPROXIMATE LIMIT OF BEDROCK AT THE EXCAVATED FLOOR (ELEVATION 9518.5 FT.)
 - SHORING INVESTIGATION BORING LOCATION
 - ▲ FOUNDATION BORING LOCATION

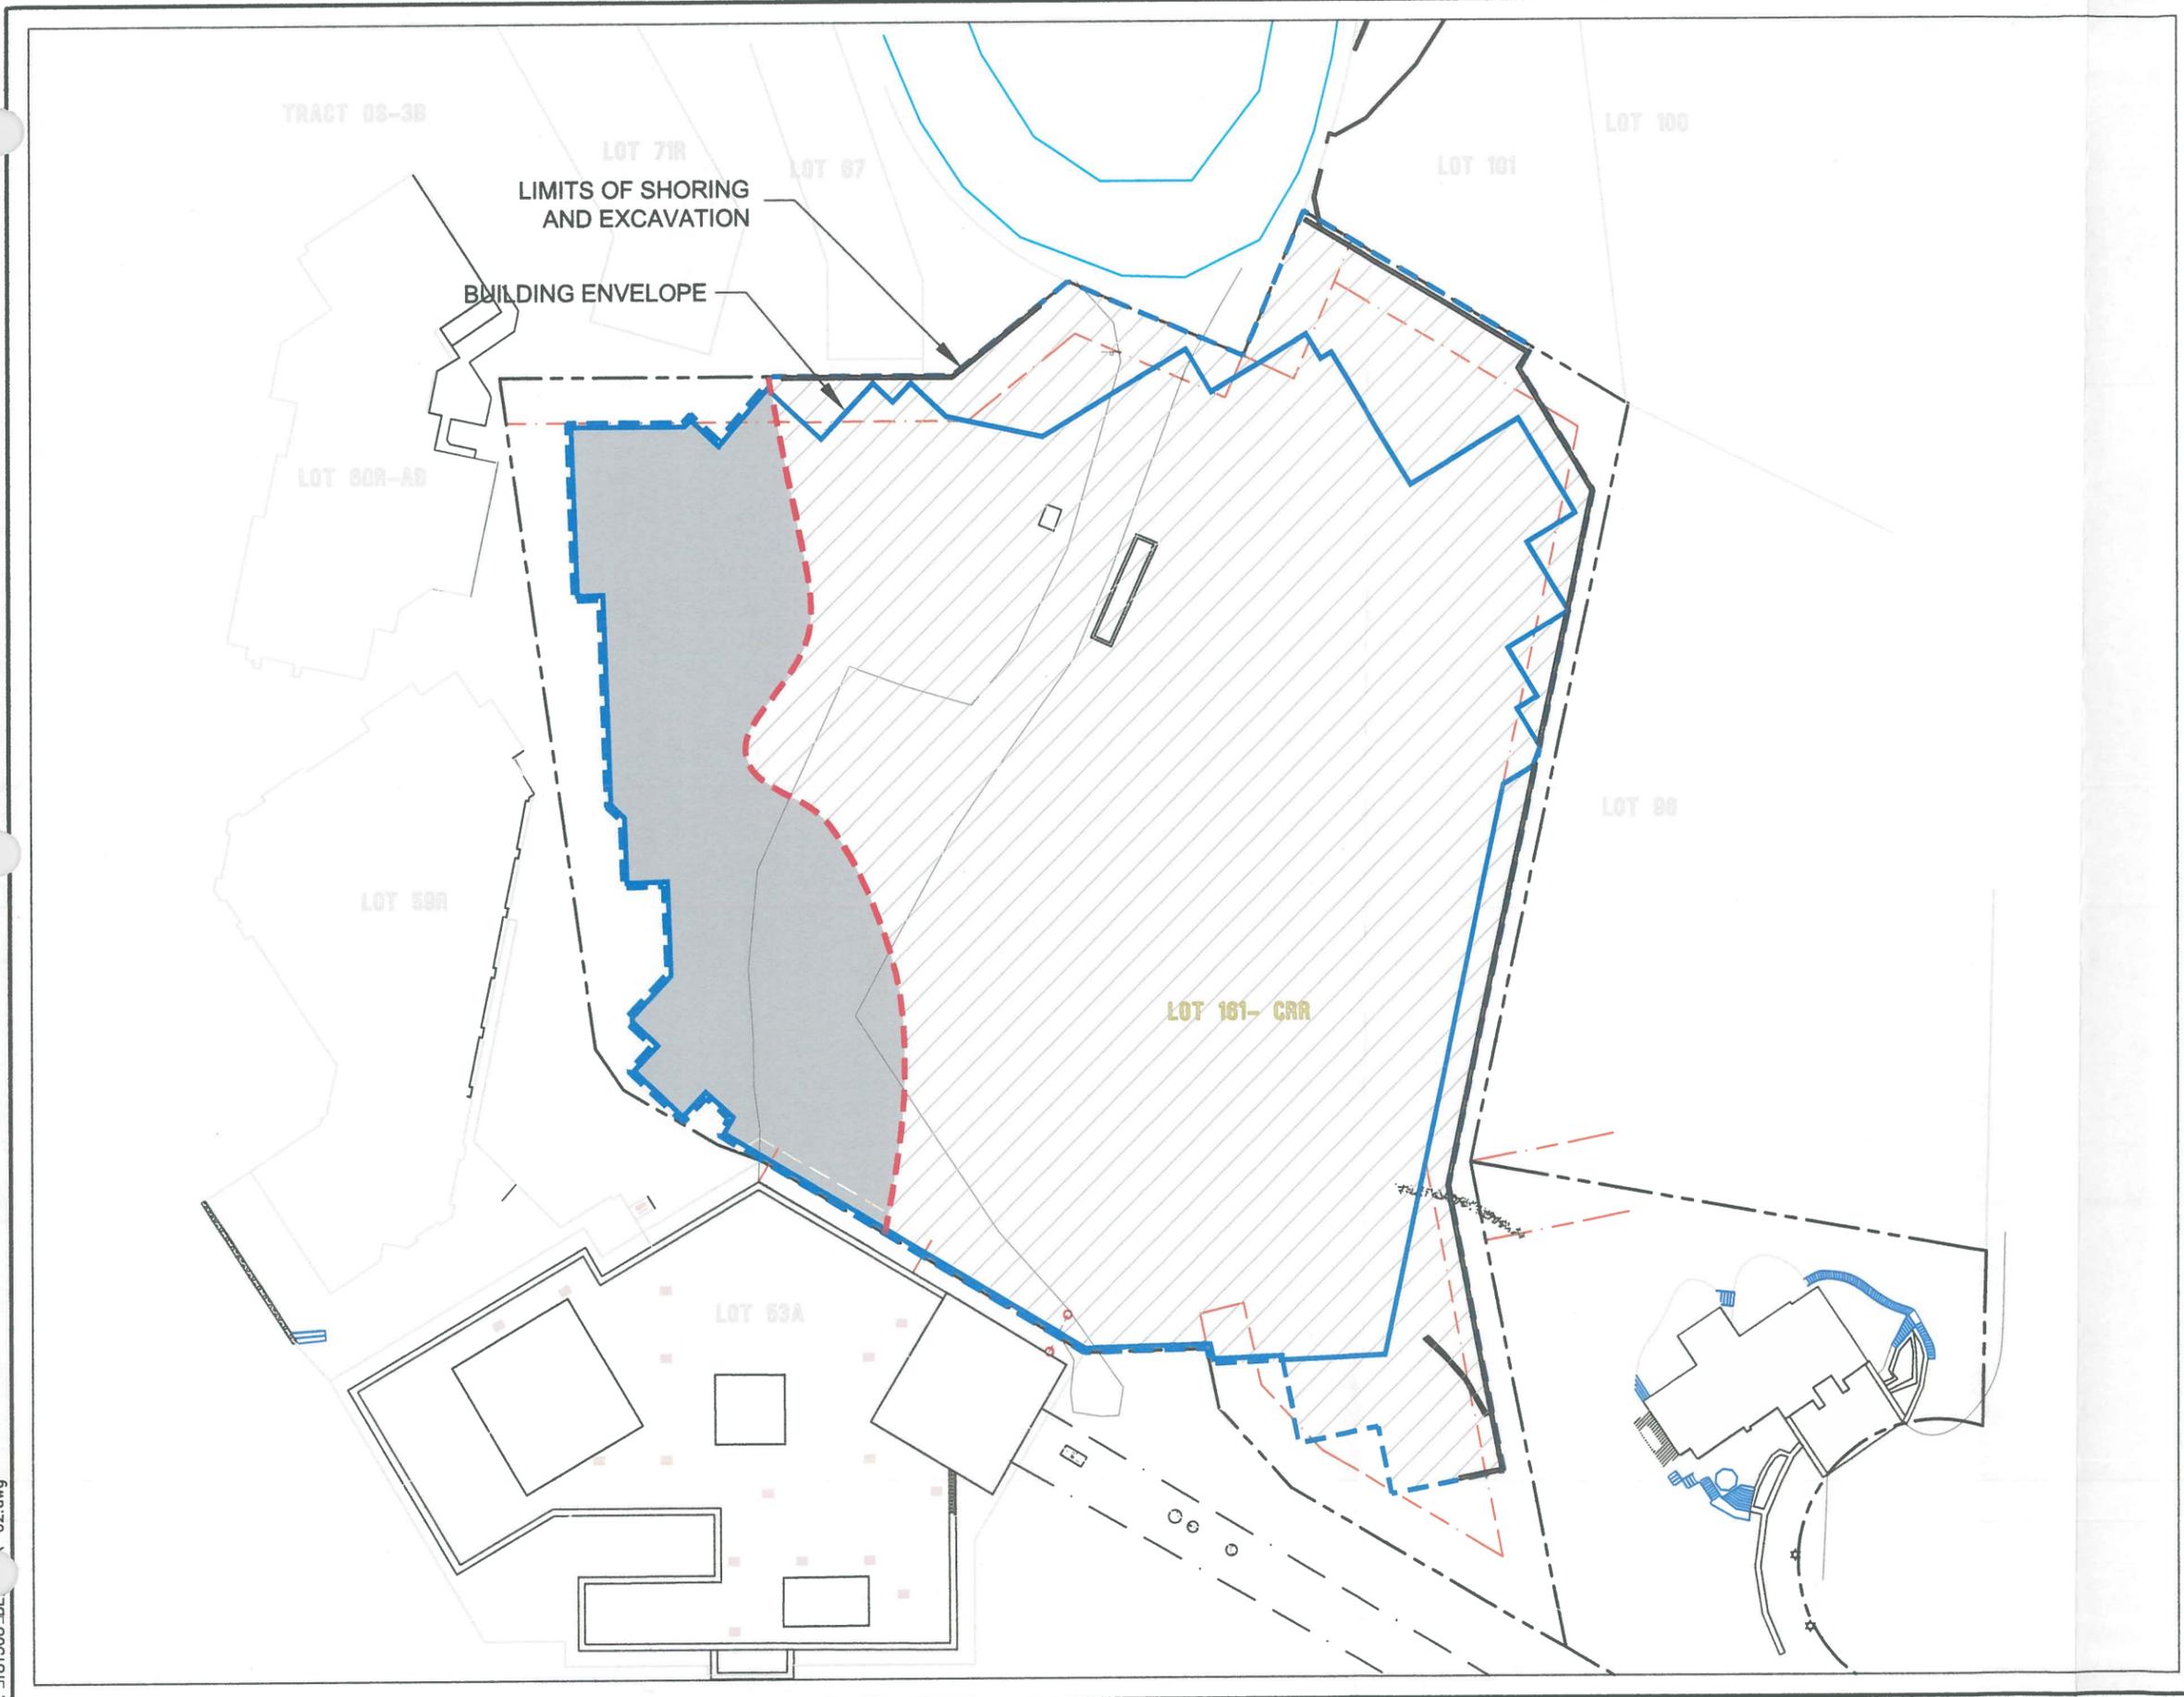
LOT 161C-R	
MOUNTAIN VILLAGE, CO	
FIGURE 12-2	
INTERPRETIVE MAP OF EXCAVATION FLOOR AT G2 LEVEL (ELEVATION 9518.5)	
PROJECT: 181308	DATE: FEBRUARY 2007
REV:	BY: TGB CHECKED: MSA
MFG, Inc.	
<i>consulting scientists and engineers</i>

- LEGEND**
- - - APPROXIMATE LIMIT OF BEDROCK AT THE EXCAVATED FLOOR (ELEVATION 9518.5 FT.)
 - AREA WHERE BEDROCK WILL BE EXPOSED IN EXCAVATION FLOOR
 - AREA WHERE BEDROCK SURFACE DIPS BELOW ELEVATION 9518.5 FT. FOUNDATION PIERS WILL PASS THROUGH OVERBURDEN SOILS

The majority of the floor of the building footprint at the G2 level (elevation 9518.5) will consist of shale and sandstone bedrock. As shown on Figure 12-2, the bedrock surface dips sharply beneath this level along the western side of the site, leaving overburden soils beneath the building footprint in this area. The overburden soils consist of unconsolidated colluvial and landslide deposits, and are unsuitable for support of floor slabs. These materials approach depths of 10 to 40 feet along the western property line; thus, the anticipated removal volumes and shallow groundwater conditions are expected to make removal of these materials economically unviable. Structural concrete slabs are recommended for areas where overburden materials remain beneath floors.
