Technical Memorandum

To:	Mr. Dale Reed	From:	Mark Abshire, P.E.
Company:	Merrimac Fort Partners, LLC	Date:	June 10, 2022
EA No.:	111217		
Re:	Lots 161C-R, 67, 69R-2, and 71R Mountain Village, Colorado Geotechnical Engineering Investigation Status Update		
Cc:	Mr. Bill Thompson (Fort Partners)

**GEOTECHNICAL ENGINEERING INVESTIGATION
FOR SHORING AND FOUNDATIONS**

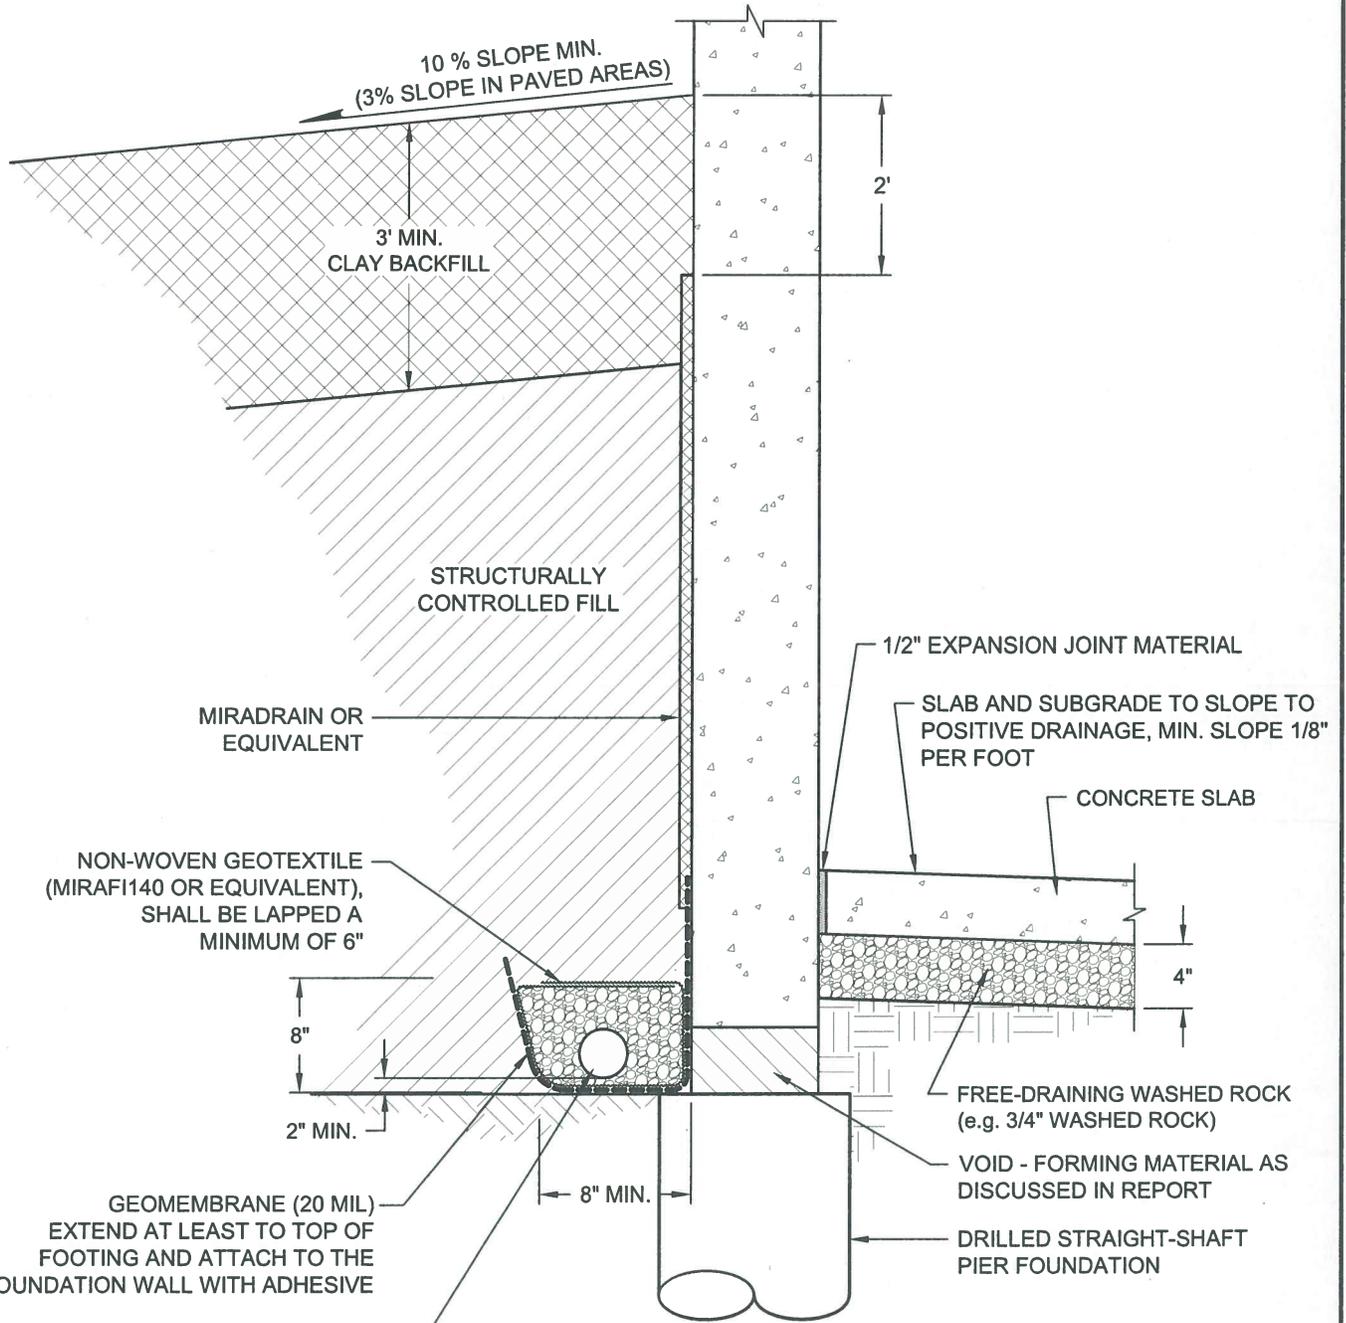
LOT 161C-R MOUNTAIN VILLAGE, CO FIGURE 12-3		
CONCEPTUAL DRILLED PIER FOUNDATION EXTERIOR PERIMETER DRAIN DETAIL		
PROJECT: 181308	DATE: FEBRUARY 2007	
REV:	BY: TGB	CHECKED: MSA
MFG, Inc. <i>consulting scientists and engineers</i>

4" DIA. PERFORATED PIPE, SCHEDULE 40 PVC, SLOPED DOWN 1/8" PER FOOT TO SUMP PIT OR COLLECTOR PIPE AND SURROUNDED WITH DRAINAGE GRAVEL. PROVIDE CAP AT UPSTREAM END OF PIPE. MINIMUM 8 UNIFORMLY SPACED PERFORATIONS PER FOOT OF PIPE.

A conceptual sketch of an exterior perimeter drain is presented as Figure 12-3. The foundation drain should outlet to daylight, a sump pit, or to the municipal storm drainage system. Municipal building officials should be contacted to coordinate the latter as approval and permits may be required. If the outlets for the foundation drain do not terminate in a heated space, they should be designed in consideration of freezing winter temperatures to ensure that they are not blocked by ice formation and accumulation.

The recommended shoring and foundation drainage systems will control the majority of water that could reach interior floor areas. However, the local geological and groundwater conditions create the potential for seepage through bedrock joints and fractures anywhere within the building footprint, although the volumes of such seepage are expected to be very low and easily controlled with underslab drainage gravel. We recommend slabs be placed on a 6-inch layer of free-draining rock (e.g. $\frac{3}{4}$ " screened rock) both to provide a capillary break and also to allow for drainage beneath the slab. The subgrade should drain at a minimum slope of 1% to a drain system, including collector pipes or sump pits, where water can be removed by pumping. A conceptual sketch of a below-slab drain is presented as Figure 12-3.

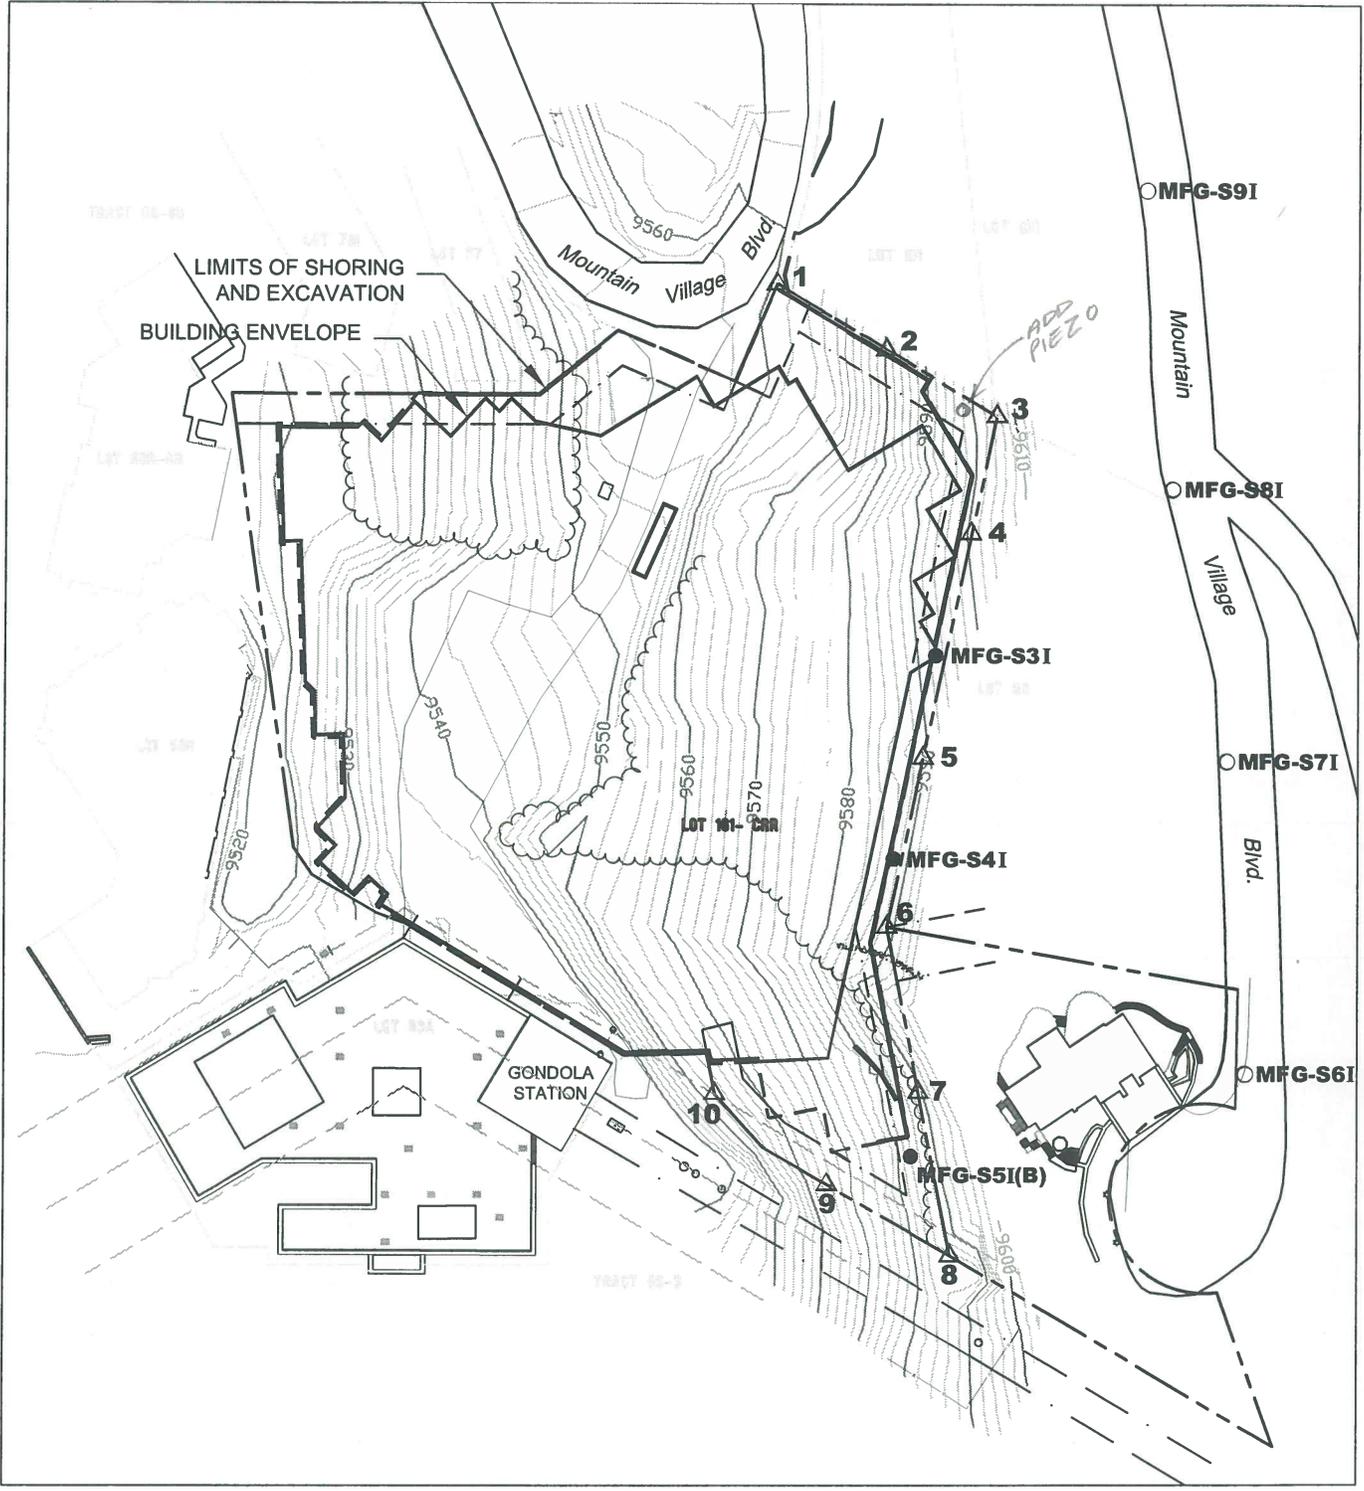
- EXISTING INCLINOMETER LOCATION
- PROPOSED INCLINOMETER
- △ PROPOSED SURVEY MONUMENT
